Manhole Inspection Summary

Manhole # S69Q__001MH

Insp Date: **5/21/08 9:36 AM**

Location Address: **1601 Danville Ave.**

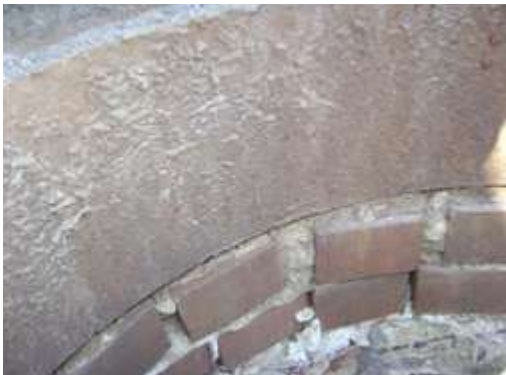
Defect 1

slight gap under frame seal

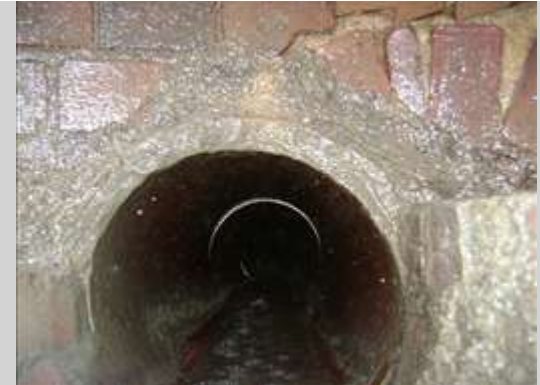
12 O'Clock Outflow

10 in. Circular Gravity Sewer
Pipe Out @ 12 O'Clock

Pipe Height: **9.6** (in.) Rod and Bar (Angled)
Pipe Material: **Clay** ☐ Pipe Lined
Invert Depth: **10.33** (ft.) Flow Characteristics: **Fast**
Deposits: ☒ None ☐ Mud ☐ Sludge ☐ Debris ☐ Grease
Silt Depth: (in.) Deposits Extent:
Infiltration: **None** Pipe Seal Cond: **Sound**

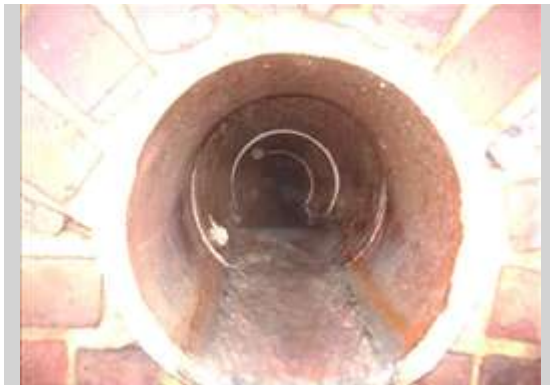
3 O'Clock Inflow

10 in. Circular Gravity Sewer
Pipe In @ 3 O'Clock

Pipe Height: **9.6** (in.) Rod and Bar (Angled)
Pipe Material: **Clay** ☐ Pipe Lined
Invert Depth: **8.17** (ft.) Flow Characteristics: **Fast**
Deposits: ☐ None ☐ Mud ☐ Sludge ☐ Debris ☒ Grease
Silt Depth: **0.125** (in.) Deposits Extent: **Light**
Infiltration: **None** Pipe Seal Cond: **Sound**

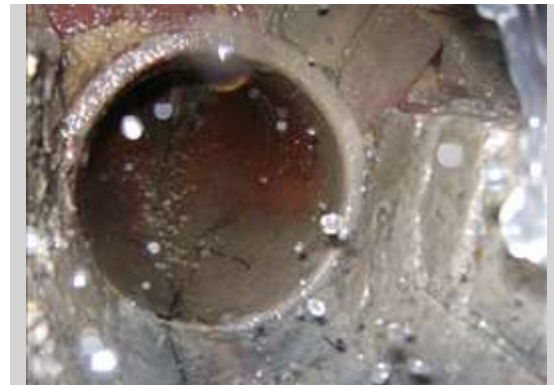
Drop In @ 3 O'Clock

Drop: **Outside** Rod and Bar
Angled: **Yes** Reading: **9.00** (ft.)
Inv Depth: **10.00** (ft.)
Drop Condition: **Partly Clogged**

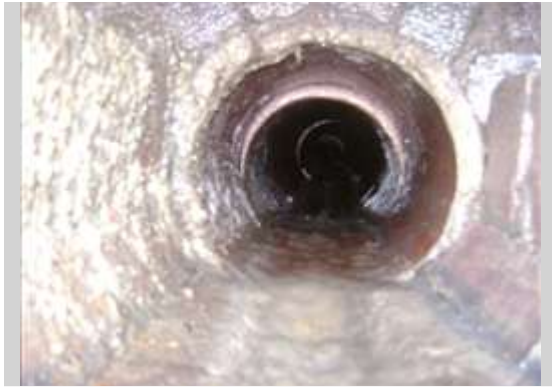
6 O'Clock Inflow

8 in. Circular Gravity Sewer

Pipe In @ 6 O'Clock

Deposits: ☒ None ☐ Mud ☐ Sludge ☐ Debris ☐ Grease

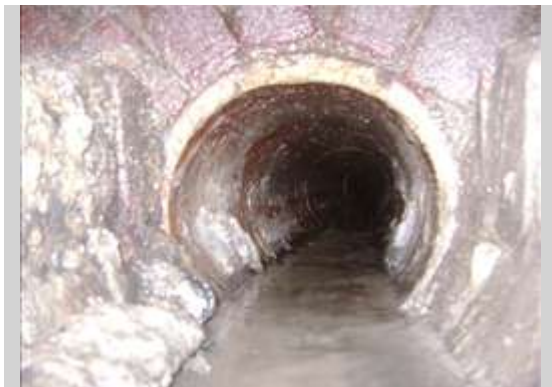
9 O'Clock Inflow

8 in. Circular Gravity Sewer

Pipe In @ 9 O'Clock

Deposits: ☐ None ☐ Mud ☐ Sludge ☐ Debris ☒ Grease

Silt Depth: **0.25** (in.) Deposits Extent: **Light**
